SHEAR RESPONSE OF REINFORCED CONCRETE DEEP BEAMS UTILIZING WASTE FIBER-REINFORCED EXPANDED POLYSTYRENE CONCRETE UNDER STATIC LOADING

Quadri, A. I., Rufai, M. K., and Ajayi, J. A. "Shear Response of Reinforced Concrete Deep Beams Utilizing Waste Fiber-Reinforced Expanded Polystyrene Concrete Under Static Loading", *Nigerian Journal of Technology*, 2025; 44(1), pp. 9 – 16; <https://doi.org/10.4314/njt.v44i1.2>

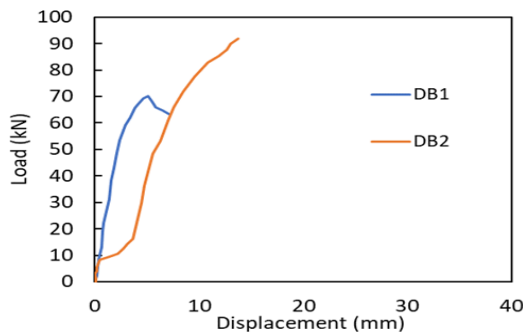
Figure 5: Load-displacement curve of DB1 and DB2 under static loading

an elastic relationship between DB1 and DB2 at about 8 kN before deviation from linearity. The initial crack in DB1 emerged at the flexural zone close to the support, and an increase in load resulted in diagonal tension failure, having a failure load of 70 kN with a displacement of 4.5 mm. DB2 failed in shear with a failure load of 92 kN and displacement of 14 mm. The presence of shear reinforcement contributed to a 31% increase in overall capacity and a 211% increase in beam ductility.

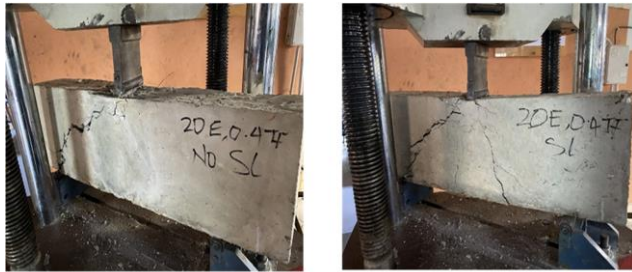
Figure 8: DB5 and DB6 at failure under static loading

The damage response of the deep beams having 20% EPS as shown in Figure 8 was assessed by

incorporating 0.4% waste tire fiber by volume of concrete. The damage response of deep beams with 20% EPS and waste tire fiber without shear links (DB5) has a very rough shear crack and showed enough ductility as shown in Figure 9. This response is similar to the damage response from Amin et al. [30] and Zeybek et al. [31]. After the aggregate interlock action loss, the fiber held the damaged planes in place which could increase the capacity of the beam with a large crack width. Contrarily, the failure of the beam with shear links having 20% EPS and waste tire fiber (DB6) shows an initial flexural crack at an applied load of 23 kN, another crack which propagated from the support section to the loading point culminates the beam damage while the flexural crack fully matured leading to diagonal tension damage with rough cracks. The shear link resisted the cracks producing a smaller crack width than DB5. A 13% difference in failure capacity was recorded between DB5 (82 kN), and DB6 (93 kN). The beam ductility is higher in DB6 than in DB5 by 78%.

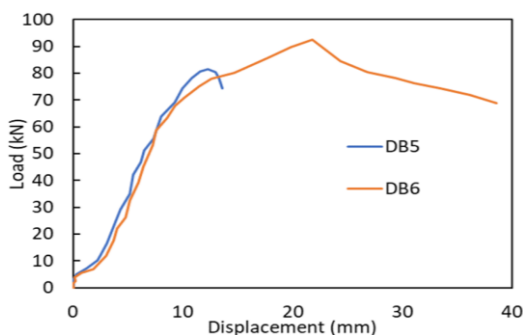
Figure 9: Load-displacement curve of DB3 and DB4 under static loading

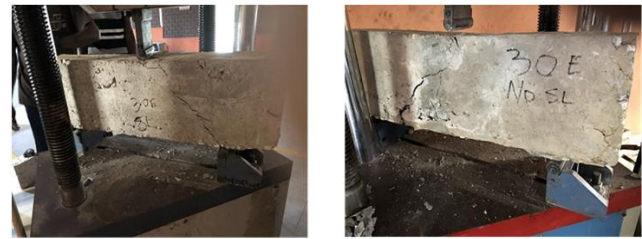
(a): DB7 (30% EPS, 0% TF, No SL) (b): DB8 (30% EPS, 0% TF, SL present)

(c): DB9 (30% EPS, 0.4% TF, No SL)

Figure 10: DB7, DB8 and DB9 at failure under static loading

Figure 10 is the damage response of the beam having 30% EPS replacing natural coarse aggregate in concrete. Shear links and waste tire steel fiber were not provided in DB7. DB8 has shear links but no waste tire fiber, while DB9 contains 0.4% waste tire steel fiber without shear links. Comparing DB7 and DB9 without the shear links, the crack width in DB9 is rough with larger ductility than in DB7 due to the

waste tire fiber contributing to resisting the cracks. The failure of DB7 is a shear brittle failure, the crack passed through the EPS aggregate at the weakest beam section. The crack width as well as the shear capacity in DB7 is thinner and smaller than in DB3, which could be due to an additional EPS percentage in DB7. The damage mode in DB8 is tension failure propagating from the flexural zone to the compression zone. Shear failure was detected in DB9.

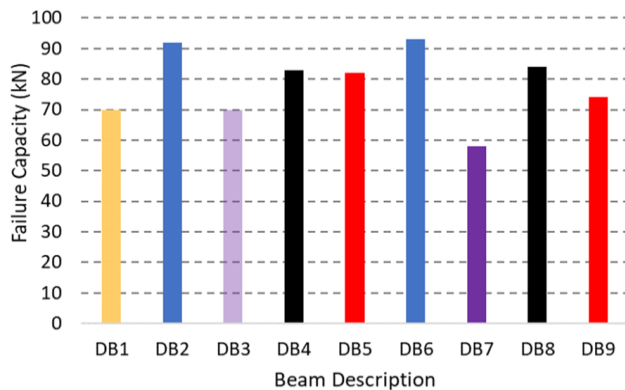
Figure 12: Comparison of the failure capacity of the test beams

Figure 12 compares the failure capacities of the experimental beams. DB1, DB3, and DB7 are detailed beams with no shear links. The capacity of DB1 and DB3 is comparable; however, an increase in EPS of more than 20% can significantly lower shear capacity, as in the case of DB7. A similar situation is seen in DB8 when compared to beams DB2 and DB6 with shear link and EPS. There is also evidence of a capacity drop between DB5 and DB9, featuring

similar concrete material constituents. Comparing DB4 and DB8 indicated no significant difference in shear capacity. Incorporating less than 20% EPS can provide appropriate capacity while also ensuring a lightweight structure capable of serving its intended purpose.
