## BIOREMEDIATION OF THE HELIOPOLIS-GUELMA GRAVEL QUARRY: A PROPOSAL FOR ENHANCING VEGETATION COVER AND ENVIRONMENTAL BENEFITS

F. Djedid<sup>1\*</sup>, and M. Bounouala<sup>2</sup>

<sup>1,2</sup>Department of Mining, Laboratory of Mineral Resources Valorization and Environment (LAVAMINE), Faculty of Earth Sciences, Badji Mokhtar University, 12, P.O.Box, 23000 Annaba, Algeria.

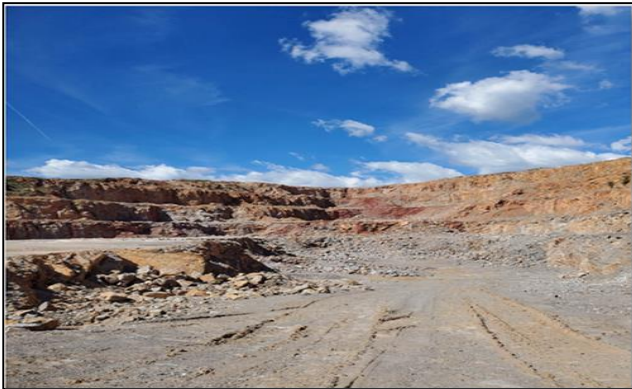
**Figure 1:** The Heliopolis-Guelma gravel quarry

The photography in Figure 1 illustrates the gravel quarry located in Heliopolis-Guelma, highlighting the steep rock walls resulting from excavations and blasting. Additionally, the image reveals exposed soil layers, which represent the geological strata of the Earth. Pebbles and small stones indicate that rock extraction continues to date. Furthermore, the scattered vegetation inevitably exists and is affected by on-site activities, while the overall landscape reflects the adverse environmental impacts of mining. The rehabilitation of mining sites covers a range of restorative activities, in accordance with the Mining Law of 1992, which consists of the establishment of a healthy and stable environment through the treatment of cases of land and water pollution, and other actions that serve both the human and environmental needs [16].

Based on this format in Figure 1, which depicts the current condition of the quarry site we aim to

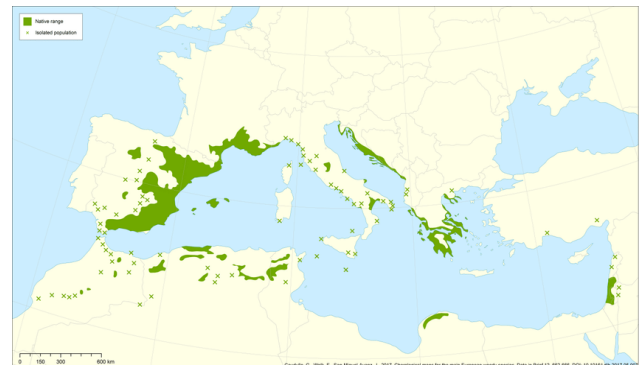
**Figure 14:** Natural Distribution Area of Aleppo Pines in North Africa and Some European Countries [22]

Additionally, they exhibit resilience to water scarcity, particularly in our study region as noticed in Figure 14, which is home to approximately 5,715.50 hectares of Aleppo pine, and 1,638.00 hectares of other pine species [7].

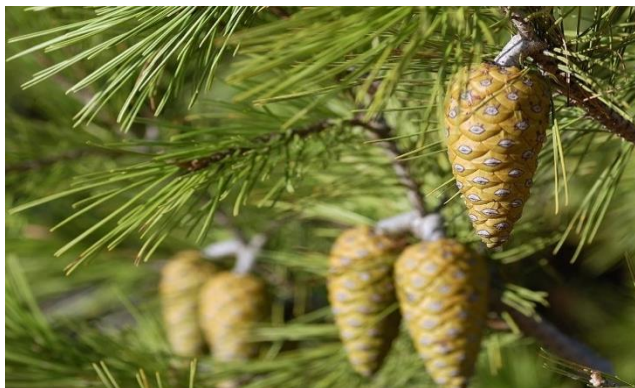
**Figure 15:** Aleppo pine in Algeria [24]

Due to their many advantages, Aleppo pine trees are the most suitable choice for our project idea. First, they provide a large quantity of seeds because they are a local variety that is exceptionally adapted to the region's climatic conditions as seen in Figure 15. This explains their wide distribution in the northeast of Algeria, where they contribute to soil stability and cohesion [23]. Moreover, the pine tree has been recognized for its resilience to challenging environmental conditions, as evidenced by its presence in the center of the quarry and adjacent to the crushing station, as illustrated in Figure 16a. Additionally, it has been observed that the pine tree demonstrates greater resistance to pollution compared to the olive tree as shown in Figure 16b, which has been significantly affected by the repercussions of exploitation, such as metallic dust. This exposure has led to reduced growth, loss of leaves, and deterioration of root health in the olive tree.

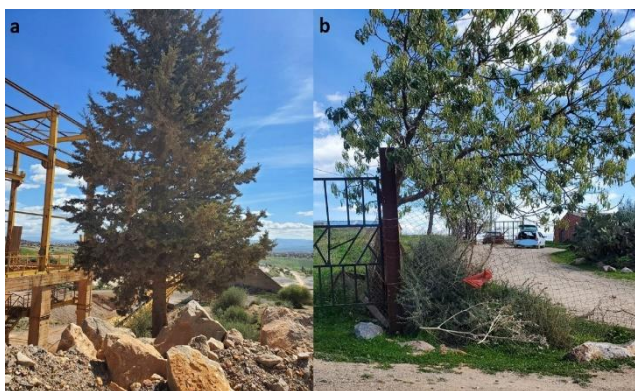
**Figure 16:** Pine and olive trees in Heliopolis quarry
