WATER INFRASTRUCTURE MAINTAINABILITY – ISSUES AND CHALLENGES IN THE COASTAL REGIONS OF AKWA IBOM STATE

B. B. Okon^{1,*}, V. E. Okon² and E. J. Udom³

¹ DEPT OF MECHANICAL ENGR'G, AKWA IBOM STATE UNIVERSITY, MKPAT-ENIN, AKWA IBOM STATE, NIGERIA

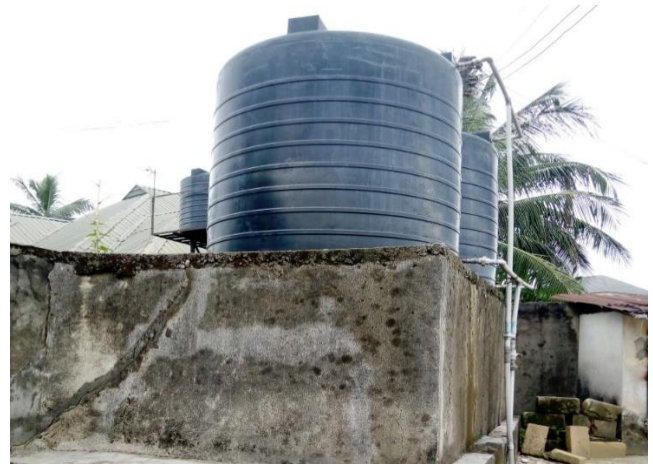
Figure 1: An elevated concrete water stanchion.

Factors such as structural stability, equipment design, tank location, elevation, and capacity should all be taken into consideration. In many cases, water is stored in reservoirs on ground level [1, 10] in order to save cost of construction, maintenance and operation, ease for water quality test, safety and aesthetic value [2]. The primary disadvantage of a ground tank is inadequate water pressure. The optimal pressure in this reservoir can be maintained through directly pumping of water. The elevated tanks, on the other hand, have a major advantage of adequate pressure and discontinuous operation of pumps. The pressure of the water flowing out of an elevated tank is dependent on the depth of the water in the tank [5]. A nearly empty tank probably will not provide enough pressure while a completely filled tank may provide enormous pressure. The two common water infrastructure stanchions considered are: elevated concrete and steel. The materials used for the construction of SWS include: steel pipes, base plate, bolts, nuts and washers. It also involves steel plate, I-beam, steel bar, angle bars and paint [8]. Equally, cement, sand, gravel, reinforcement rods and water can be used in the construction of CWS [9]. The pictorial views of these stanchions from the studied areas are shown in Figures 1– 2.

on them. The results from other tested factors did not show major variations. On this premise, it points to the fact that steel stanchions are susceptible to thermal expansion when exposed to high temperature over concrete. From this study also, installation of the necessary water supply and distribution mains, branches and appurtenances on the water infrastructure are very essential but priority attention is on periodic maintenance of the water facility. It is however adduced from this study that continuous (periodic) and practical maintenance culture is a panacea, for effective water infrastructure sustainability. This study further established better ways of tackling these problems which are indicative risks concerning maintainability of water infrastructure for optimum service delivery as indicated in Figures 1 and 2.

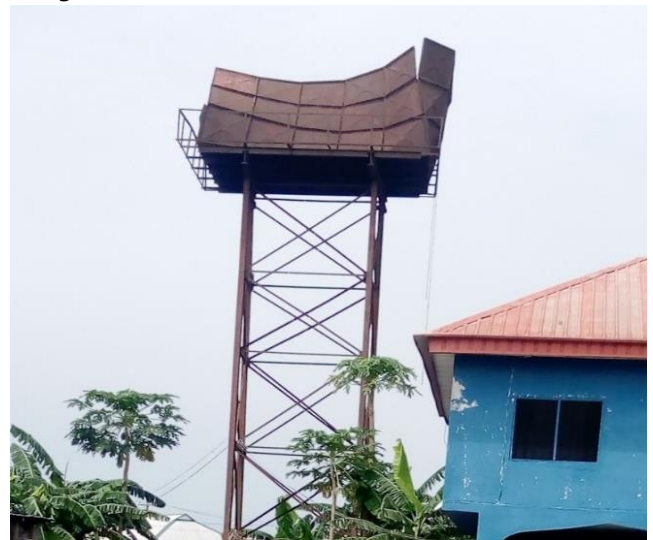
Figure 2: Elevated steel water stanchion.
